# **MERIDIAN TOWNSHIP PHASE II ENERGY EFFICIENCY PROJECT - PART 1**

## **FINAL REPORT**

May 18, 2015

Submitted by Bob Tinker, RA, LEED AP

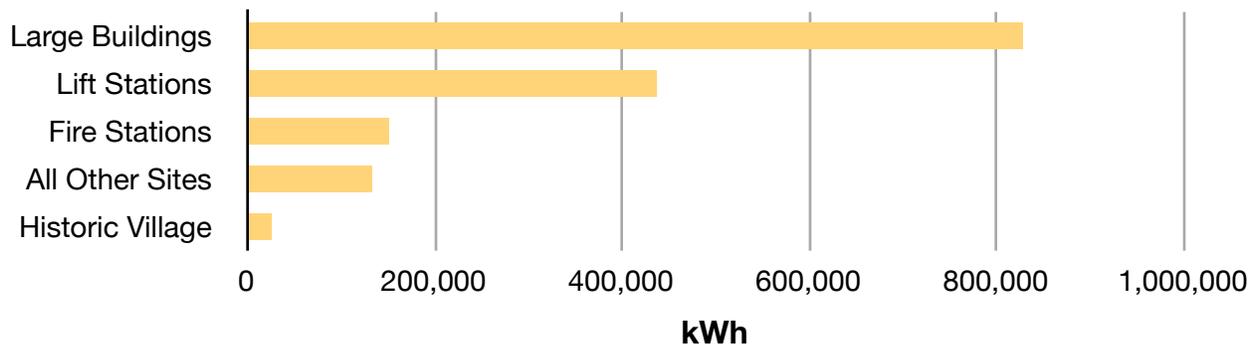
### Township Facilities Electrical Consumption - 2014

The following charts display the 2014 total annual consumption for electricity (in kWh) and gas (in CCF) for 5 categories of Meridian Township facilities. The first category includes the 3 largest township buildings: the Municipal Building, the Public Safety Building and the Service Center Building. The Lift Stations category includes 31 locations around the township for Water Infrastructure. There are 3 Fire Station facilities. The Historic Village has 6 buildings on site. The last category includes 13 other township buildings or facilities at separate locations.

The three largest township buildings constitute over half of the total electricity consumption. These buildings previously had energy audits and energy retrofit projects effecting electrical consumption. This report documents the remaining potential for energy savings for these three buildings. The Lift Stations use more than 1/4 of the electrical energy. Walk through energy audits were conducted of the largest of these facilities. The results of this effort are provided in the this report. The Fire Stations are responsible for 10% of electrical use. One of the three fire stations was previously audited and a second was audited for this report. The Historic Village constitutes just 2% of electricity consumption. A walk through audit was conducted for the Historic

Village. The electricity consumption for the remainder of all township facilities amounts to about 8% of the total. The Nature Center previously had an energy retrofit project. Both this building and the Activity Center were audited for this report.

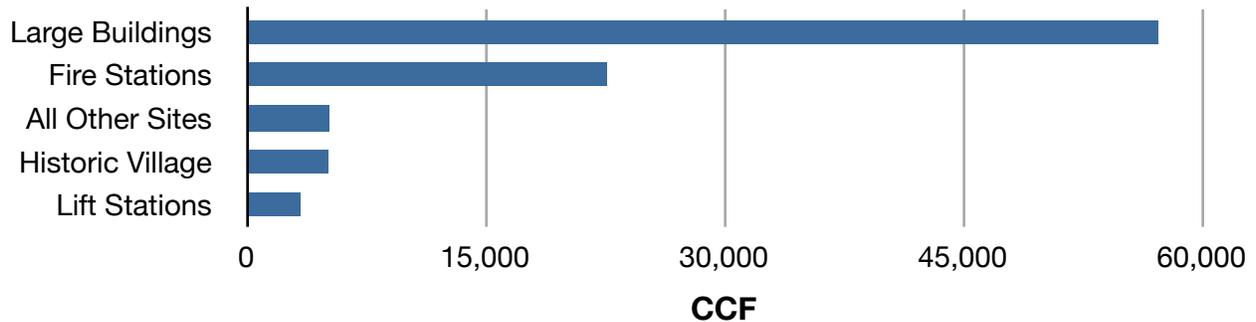
### Township Facilities Gas Consumption - 2014

The three largest township buildings constitute almost 2/3 of the total gas consumption. These buildings previously had energy audits and energy retrofit projects effecting gas consumption. This report documents the remaining potential for energy savings for these three buildings. The Fire Stations gas consumption amounts to almost 1/4 of the total. One of the three fire stations was previously audited and a second was audited for this report. The Historic Village and the Other Sites Category both use about 5% of the total gas. Analysis of gas consumption and discussions with management indicate that the Historic Village buildings are not insulated. The Nature Center previously had an energy retrofit project. Both this building and the Activity Center were audited for this report. The Lift Stations constitute just 4% of gas consumption. The largest of these facilities was audited for potential energy savings.

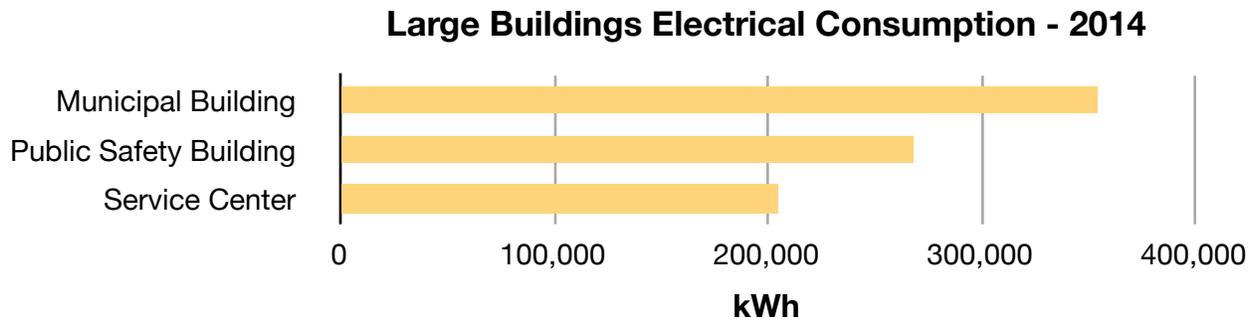
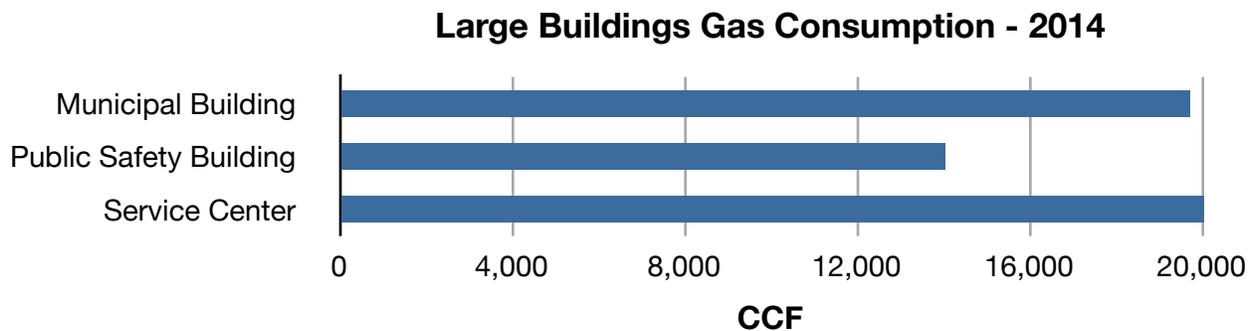
The charts below show the annual electrical and gas consumption for the three largest township buildings.

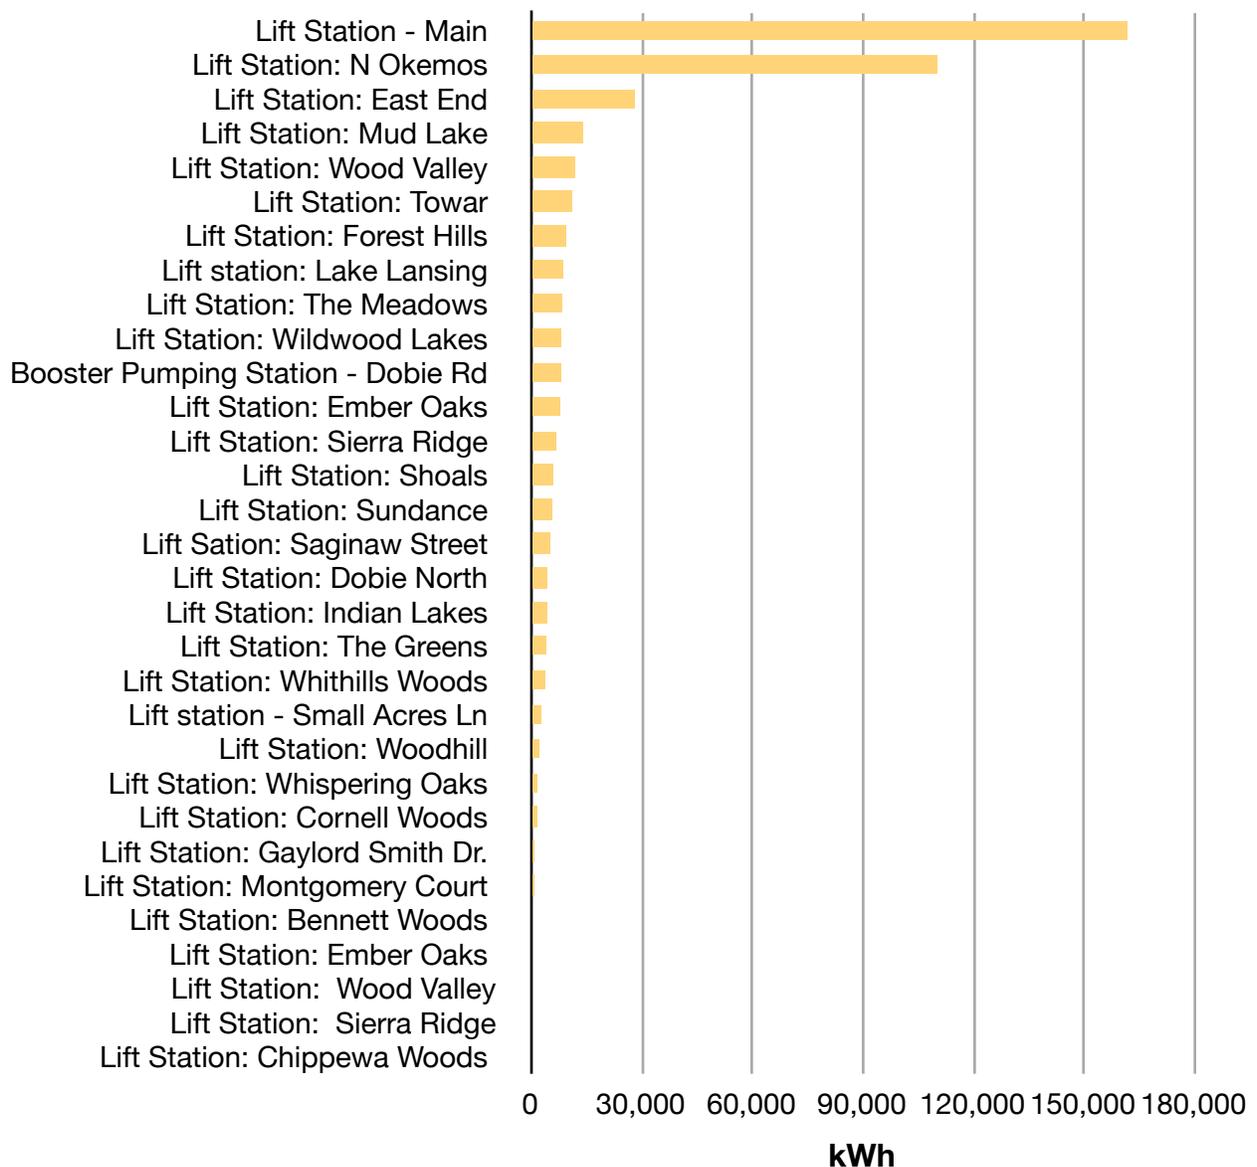
**Water Infrastructure Electrical Consumption - 2014**

The chart below shows the annual electrical consumption for each of 31 Water Infrastructure locations. Over 62% of the total is used by just 2 locations. Walk through energy audits were conducted for these two locations. Both facilities were found to be clean, modern, and up to date. The lighting systems were efficient. The pumping equipment was controlled by variable speed drives providing the most efficient power when needed. No improvements are recommended. The remaining locations are pumping stations that are active on an as needed basis. The larger of these pumps may benefit from variable speed drives in the future.

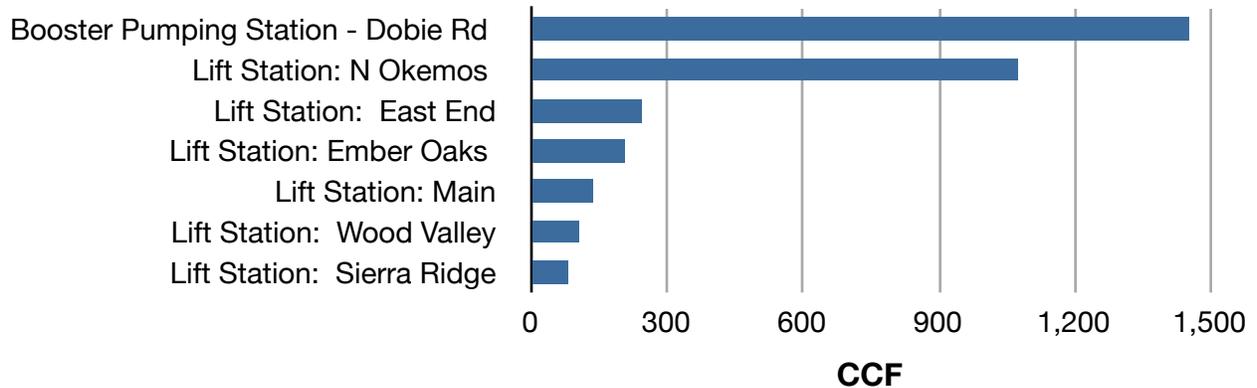
### Water Infrastructure Gas Consumption - 2014

The chart below shows the annual gas consumption for 7 Water Infrastructure locations. The use of gas is for space heating to keep the pumping equipment from freezing and to heat fresh air that is code required for such facilities. Gas consumption is not significant except for two locations. These are equipped with direct fired rooftop heating only units. The sensor controls for these two facilities may want to be checked to determine if the current, apparently large, ventilation rates are really necessary.

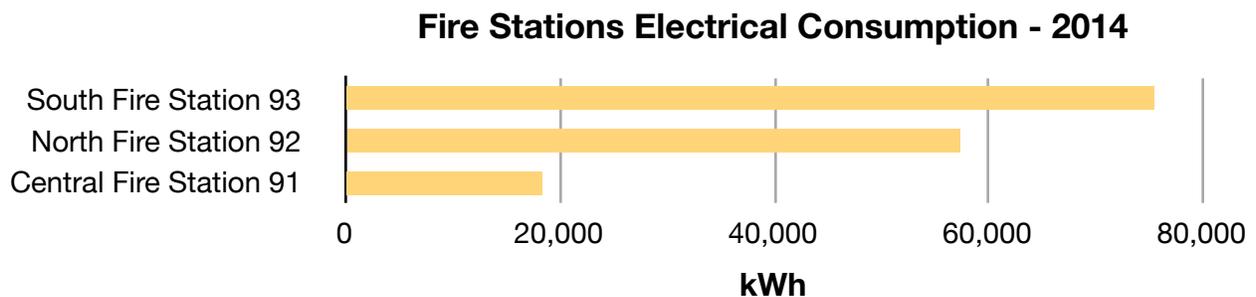
The chart below shows the annual electrical consumption for the 3 Fire Station locations. The South Fire Station has the largest consumption of electricity. This building was previously audited. In October of 2011, its base electrical consumption dropped by about 40% and has stayed there at that level. This report discusses the reasons for this energy reduction and presents additional potential energy savings as determined from that audit. The North Fire Station received an energy audit for inclusion in this report. The Central Fire Station has been closed for some time but still shows significant electricity use. A site visit to document this energy use is recommended and steps should be taken to eliminate unneeded equipment operation.

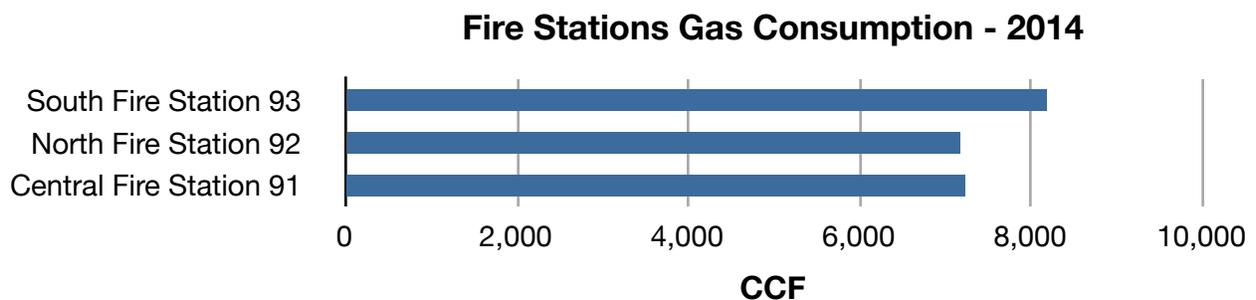
The chart below shows the annual gas consumption for the 3 Fire Station locations. The South Fire Station had slightly more consumption of gas than the other two. This building was previously audited. This report presents the potential gas energy savings as determined from that audit. The North Fire Station received an energy audit for inclusion in this report. The Central Fire Station has been closed for some time but still shows consumption nearly equal to that for the South & North. A site visit to document this energy use is recommended and steps should be taken to eliminate unneeded equipment operation.

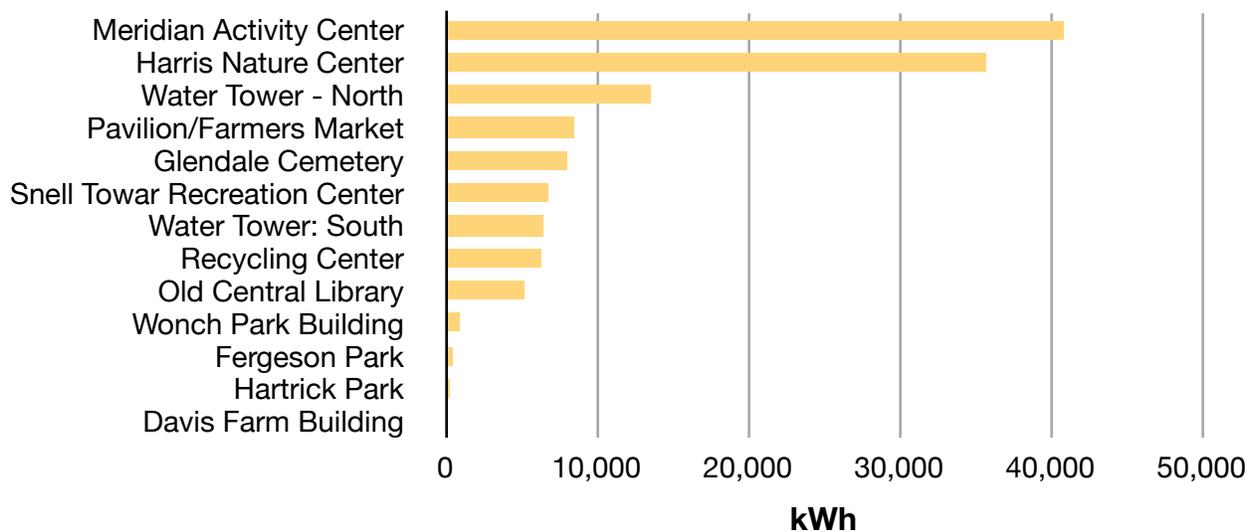
**Other Township Sites Electrical Consumption - 2014**

The remaining properties have electrical consumption similar to that for a large residence. Based on site visits to the Glendale Cemetery and Farmers Market Pavilion, this consumption is believed to be mostly for interior and exterior lighting. There are opportunities to update to more efficient lighting: linear fluorescent to T8 technology, incandescent to CFL or LED, and exterior HID to LED or induction. Occupancy Sensors may also be beneficial in some instances. Both Consumers & BWL offer rebates for lighting retrofits. Malfunctioning timer or photocell controls on exterior lighting fixtures, as observed at the Pavilion restroom entries, should be given immediate attention and may be candidates for an LED replacement.

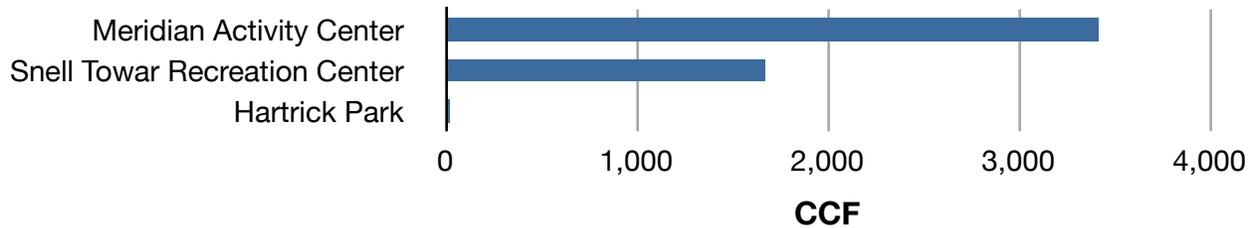
### Other Township Sites Gas Consumption - 2014

The chart below shows the annual gas consumption for 3 township facilities at separate scattered locations. The Meridian Activity Center gas consumption, the largest of these, is discussed in the audit results provided later in this section of the report.

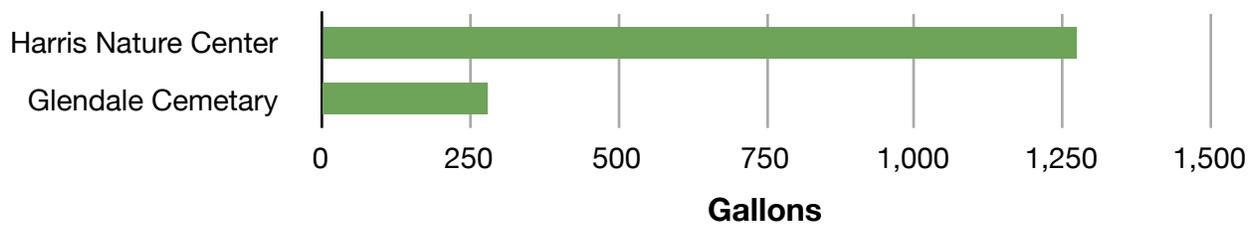
### Other Township Sites Propane Consumption - 2014

Two of the scattered sites use propane for space heating. The Harris Nature Center propane consumption is discussed in the audit results provided later in this section of the report.

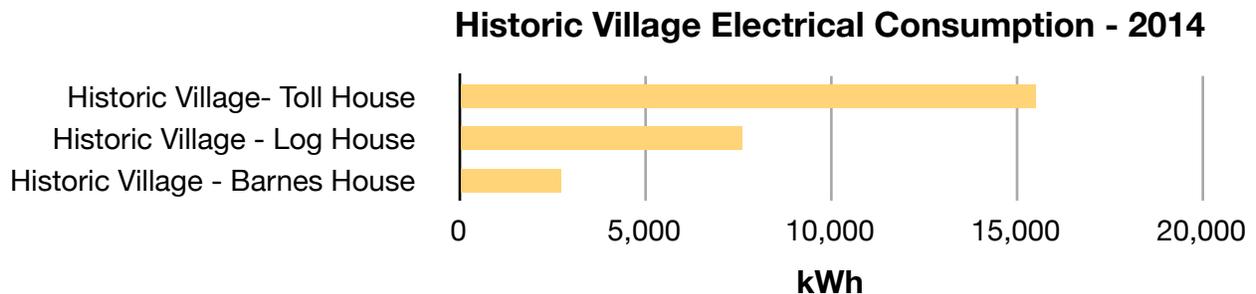
As shown below, the Historic Village has only three electric meters for the 6 buildings on site, so, except for the Barnes House, the actual consumption for each building cannot be determined from the billing history. If the consumption is averaged over all buildings, the electricity use for each is similar to that used by a modest single family home. Since these buildings do not have typical modern household appliances in them, the electrical consumption is thought to be due mainly to interior and exterior lighting. An on-site walk through of the Village determined that almost all of the lighting fixtures use incandescent lamps. It is believed that incandescent lamps will best compliment the historic nature of the buildings. However, there currently are both CFL and LED lamp shapes identical to the incandescent that could be used as replacements. These technologies would consume from 75% to 90% less energy, saving over \$1,300 annually. Incentives are still available from Consumers Energy which would mostly pay for new LED lamps.

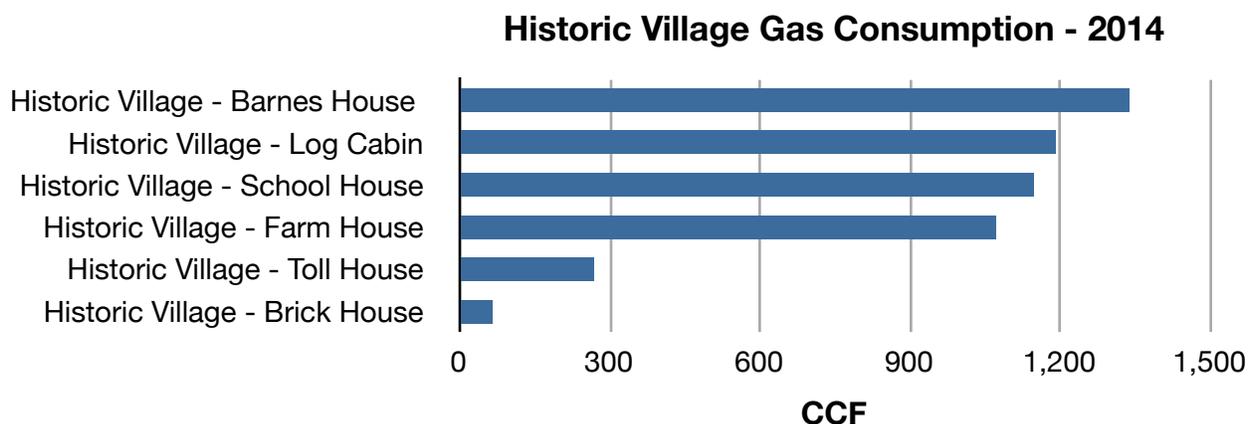
The chart below shows the gas consumption for each of the 6 buildings on the Historic Village site. Four of these buildings have annual consumption significantly greater than a modest single family home. This appears to indicate that the buildings have uninsulated attics and/or walls. Management may want to consider a study to evaluate ways of insulating these buildings without creating maintenance problems. An architect or other insulation specialist may want to be retained. Energy savings of a least 1/3, valued at over \$1,100, could be expected. These buildings also have single pane windows. For energy savings and to protect the primary windows from damage from the elements, the installation of exterior Low-E storm windows may want to be considered. Updating the heating equipment may also provide significant savings.
